Re: 1973 Well #1 - POLK995 (PR# [23-2026](#))
Bjornson Vineyard (PWS ID# [95772](#))
Site Plan & Well Evaluation

Well Log Evaluation Results – POLK995

As Built Well Construction Evaluation for Plan Review and/or Setback Waiver:

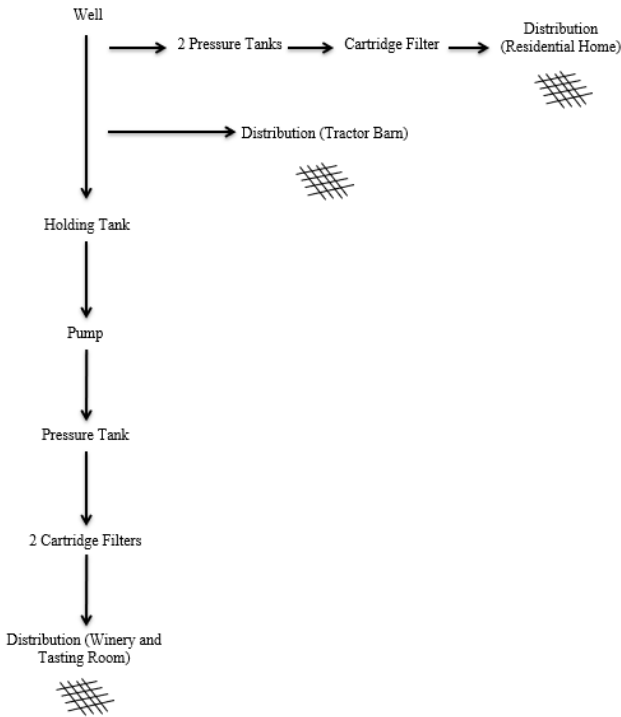
OHA geologist, Tom Pattee, evaluated the well log (POLK995) and found that the well did not meet construction standards due to an inadequate seal. More details regarding this evaluation are as shown below.

Comments: This well was drilled to a depth of 400 ft. The well is cased to a depth of 36 ft and is reported to have been sealed to a depth of 35 ft using 2 sacks of cement. The casing seal appears to be suspect due to an insufficient amount of cement used to create the seal. Calculations suggest that constructing a 35 ft seal in a 9-inch borehole with 6-inch casing would require about 5.5 sacks of cement, 3.5 sacks more than were reported on the well log. Therefore, the well does not appear to meet current construction standards. Water can enter the well through the uncased portion of the well from 36 to 400 ft below ground level. Sensitivity Analysis results suggest that well construction is highly sensitive to nearby land use practices due to the casing seal.
